Re: Target Riverdale Plaza Precast Panel Failure
WJE No. PC09.1981

At the request of Faegre & Benson LLP and Target Corporation, WJE Engineers & Architects, P.C. (WJE) has performed a limited investigation to opine on the cause of the precast panel connection failures at the Target store T1798 located in Bronx, NY. This letter serves as our report on this matter.

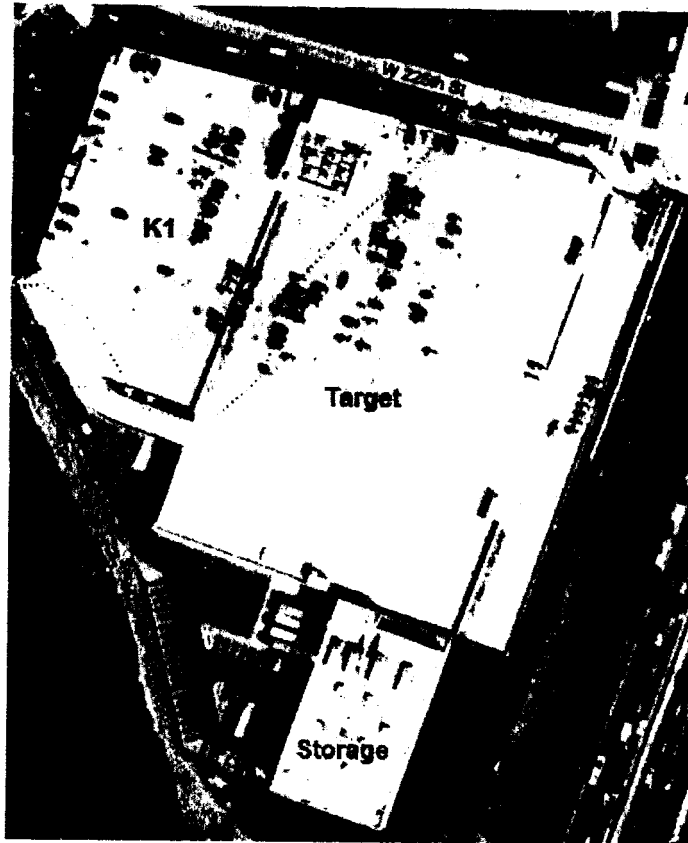
Figure 4- Plan View of Store Showing Expansion Joints (Red Lines)

The Target Store is located in the Riverdale Plaza which is located at 300 West Kingsbridge Road (40 West 225th Street), Bronx, NY. The large structure that houses the Target store also has an additional retail space (K1). The Target portion of the building in plan view is comprised of two rectangular sections. The main section has outside dimensions of approximately 297 ft. east/west by 477 ft. north/south (Figure 1). The other section, which houses receiving and warehouse spaces, extends from the southeast corner of the main section and has outside plan dimensions of about 180 ft. north/south by 109 ft. east/west (Figure 2). The K1 retail portion of the building is rectangular in plan with a truncated southwest corner. It has outside dimensions of approximately 227 ft east/west and 308 ft. north/south (Figure 3). All of these sections are separated from each other by expansion joints as shown in figure 4. The building is a 1 story structure with a mezzanine level.

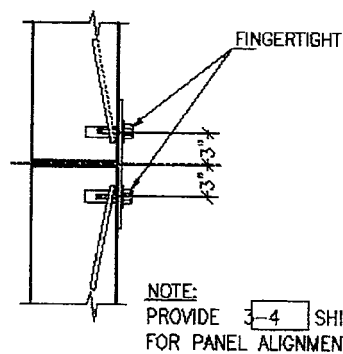
Figure 28- Typical Precast Panel to Panel Connection

TT acknowledges that panels in corners cannot be impacted by snowplows. The TT report postulates that the failed connections of precast panels that are protected from a direct impact are the result of the impact forces of adjacent panels being transferred through the inter-panel connections. The inter panel connection shown in Figure 28 consist of a plate crossing the panel joint with a single bolt on either edge of the panel. The tensile capacity of this bolted panel edge connection is about 4000 lbs, which is less than that of the lateral panel insert connection (type 62). Therefore, the panel-to-panel connection will fail long before sufficient load is transferred to fail the slotted insert connection. Furthermore, if forces were being transferred from an impacted panel to an adjacent panel, twisting of the panels would be observed at the panel joints. WJE did not find observe any panels that appeared to be twisted or out of alignment relative to the panel directly adjacent to it.
